## Home Inspection Report

1202 Oxford Street, Round Rock, TX 78665

Friday September 1, 2017

Mulling Home Inspection Services

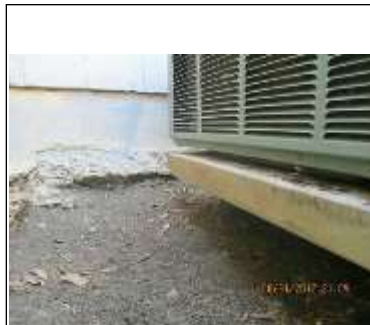
Erosion of soil at the foundation on westside.

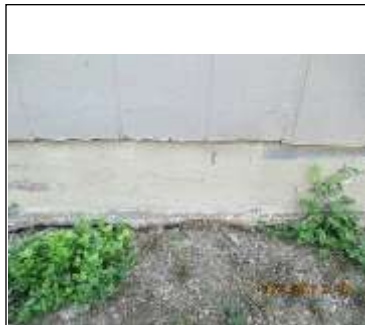
Shows erosion of soil away from foundation

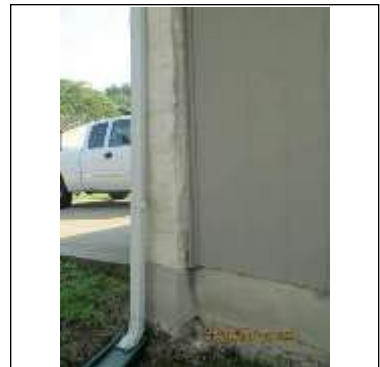
Surface deterioration (known as spalling) was observed on the exterior of the exposed foundation walls. This condition is common in many homes and does not usually represent a structural concern. In an effort to prevent long term deterioration, it would be wise to consider parging deteriorated areas. Lot drainage improvements, as outlined in the "Exterior" section of this report are also recommended.

Deteriation of foundation from erosion

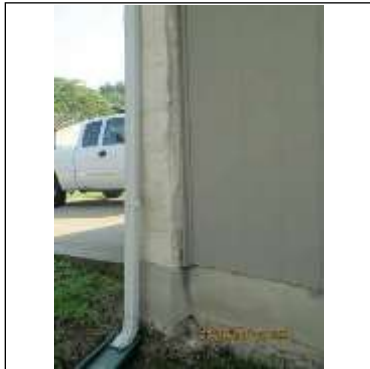
Damaged downspout, erosion of soil, and deterioration of foundation.

Loose or damaged downspouts should be evaluated by a roofing professional and repair as needed.

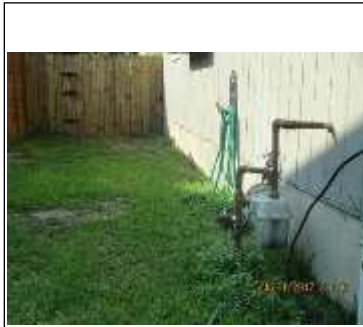
Comments: The grading should be improved to promote the flow of storm water away from the house. This can usually be accomplished by the addition of top soil. The ground should slope away from the house at a rate of one inch per foot for at least the first ten feet. Ideally, at least eight (8) inches of clearance should be maintained between soil level and the top of the foundation walls.

Negative grading towards northside foundation, lack of swale

A drainage swale (if effect, a wide and shallow ditch) should be created. Drainage swales are intended to divert storm water away from the house and ultimately off the lot.

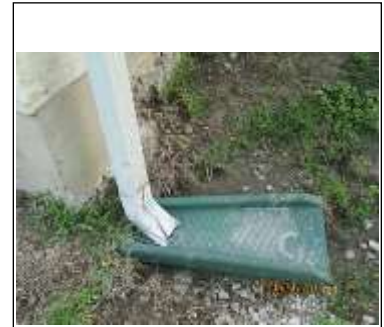
Another shot of damaged downspout

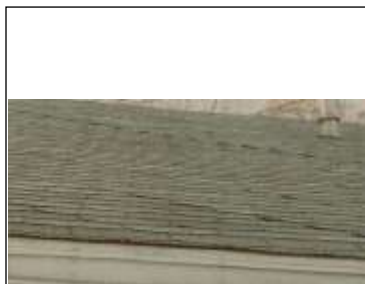
*Comments:* Some standing or puckered shingles were noted along with roof aggregate material in the gutters.

Shows some puckering of shingles

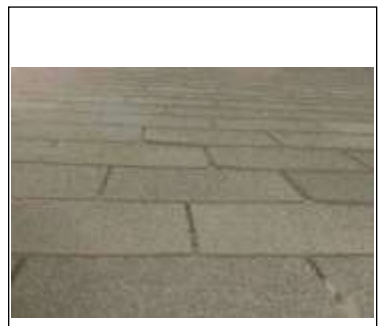
The roofing is considered to be in good condition. This roofing is wearing at uneven rates. The sides of the roof that are most exposed to the sun's light are wearing more quickly than the more shaded areas. Consult with a roofing contractor to determine that a repair or replacement of deteriorated roofing may be needed in some areas, prior to the entire roof covering requiring replacement.

Some evidence of wear and shingles standing or pulled up.

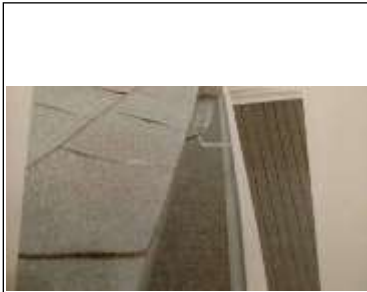
Roof material in gutter, another sign of normal wear and gutter needs cleaning

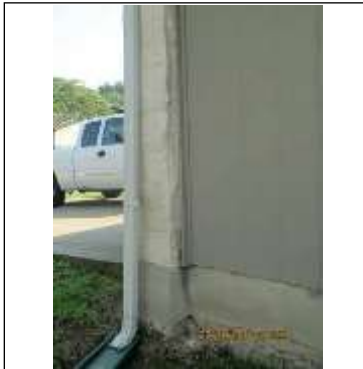
Damaged downspouts

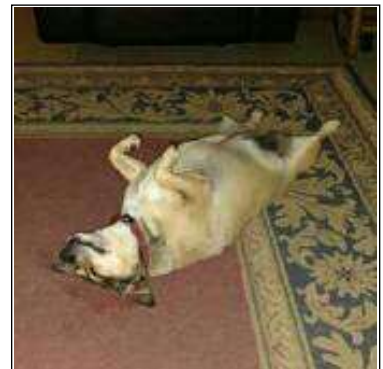
There is evidence of vermin activity. A pest control specialist should be consulted in this regard.

Vermin Activity (just kidding-this will not be in a report)

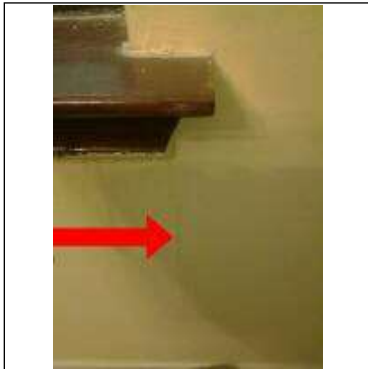
Small hairline crack repair under window in dining room

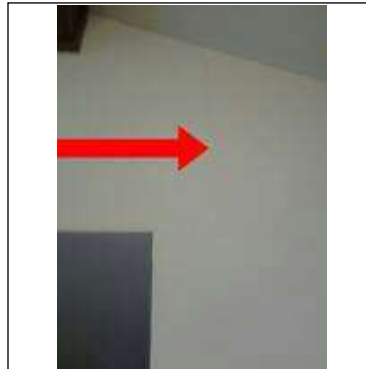
Typical drywall flaws were observed. This condition is mainly cosmetic in nature and should be patched.

Ex. Of living room sheetrock crack

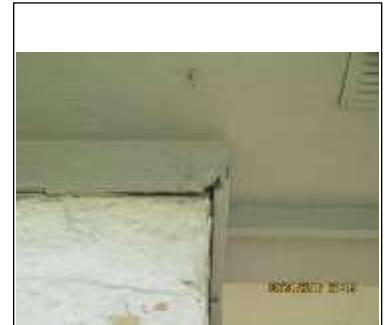
Trim needing to be caulked and sealed

Trim and seams need to be sealed to prevent water penetration and wood rot.

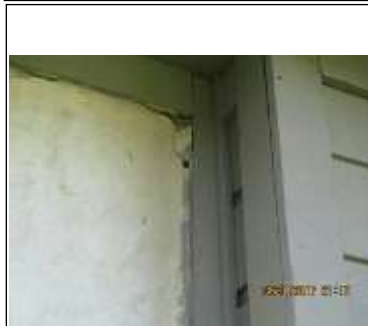
Another trim needs sealant between Austin stone and wood siding

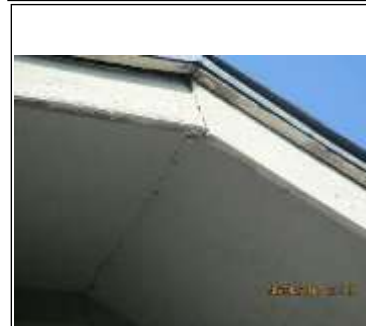
Trim at top eave needs to be attached better and sealed from weather

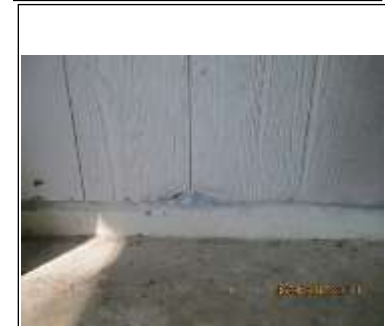
Masonite siding that shows signs of deterioration. Recommend that a qualified professional

"Masonite" siding shows signs of wear and deterioration

evaluation and then repair, seal, or replace as necessary.

Siding that and trim that needs to be repaired, sealed, or replaced as recommended by contractor.

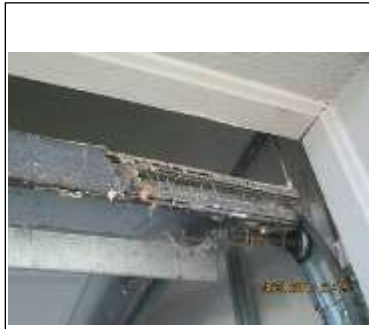
The overhead garage door bottom weather strip seal is damaged and needs repair or replacement.

Garage door weather stripping is torn

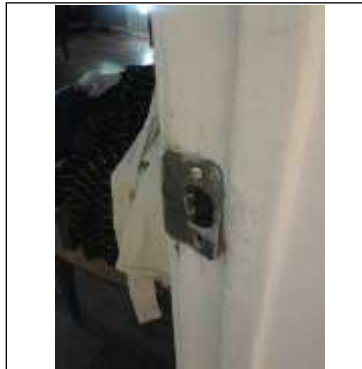
*Comments:* Master bedroom door has damaged or non-functional door hardware that should be repaired or replaced as needed.

Damaged master bedroom door hardware

Master bedroom door hardware needs to be repaired or replaced for intended function.

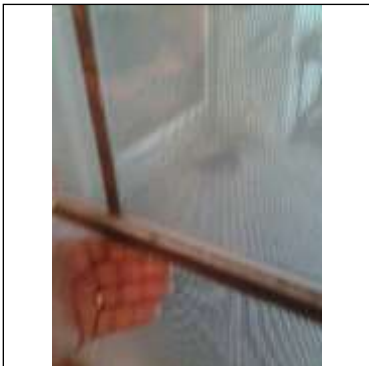
The window(s) in the dining room are inoperative. Improvement can be undertaken to allow normal operation of the window. All the window issues will need to be addressed with a window contractor to repair or replace glazing.

Dining room window springs do not hold window in an open position.

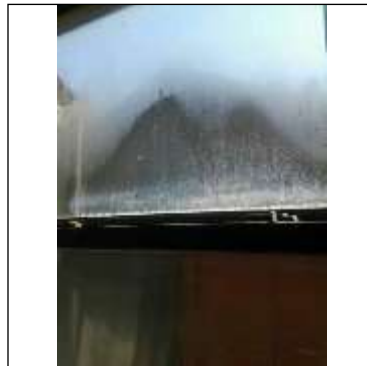
*Comments:* The window(s) in the master bath and guest bedroom have lost their seal. This has resulted in condensation developing between the panes of glass and can cause the glass to lose its insulating properties. The glass should be repaired or replaced. The windows show evidence of condensation. This is not a major concern. Controlling indoor humidity levels and/or improving window efficiency (if needed) would help to control this condition. It may be desirable to replace window screens where missing. The owner should be consulted regarding any screens that may be in storage.

Broken seal in master bath window

Exterior windows with broken seals and bedroom window missing outside pane should all be evaluated by a window contractor for repair or replacement.

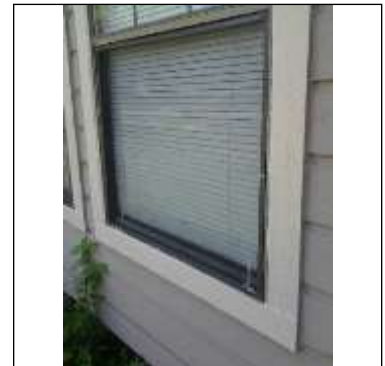
The exterior pane of glass is missing from the front bedroom window and should be replaced. TREC LIMITATIONS: The inspector is not required to exhaustively observe insulated windows for evidence of broken seals; exhaustively observe glazing for identifying labels; or identify specific locations of damage.

Exterior window pane missing from double paned window on front bedroom

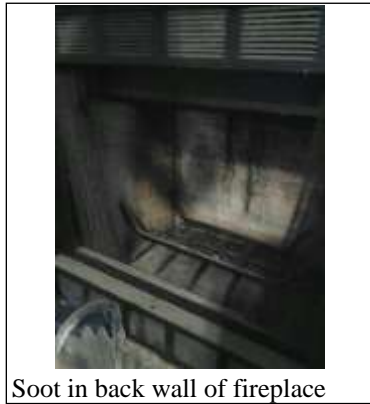
The rear wall of the fireplace firebox shows some damage and should be repaired for improved safety.

Significant creosote buildup was noted in the fireplace flue and/or firebox. Cleaning of these areas should be undertaken for improved safety.

The fireplace has gas starter present. No damper stop is installed and requires repair. Damper stops reduce the risks of carbon monoxide poisoning.

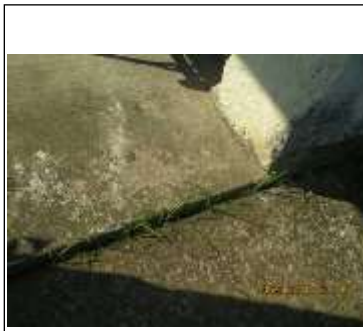
The front porch area has settled relative to the house proper. This is a common condition that should be monitored. The seam between the porch and sidewalk should be sealed to prevent any further erosion.

Transition between front porch and sidewalk has settled and needs to be sealed

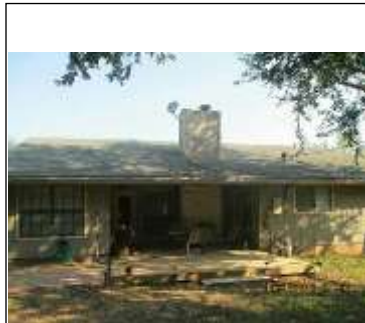
Service Drop and tree branches needing to be trimmed

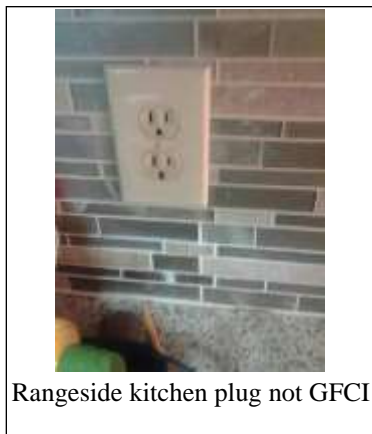
Rangeside kitchen plug not GFCI

The installation of a ground fault circuit interrupter (GFCI) on the range side in the kitchen and in the garage, is recommended. A ground fault circuit interrupter (GFCI) offers protection from shock or electrocution.

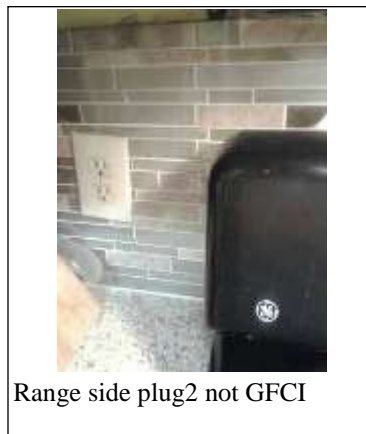
Range side plug2 not GFCI

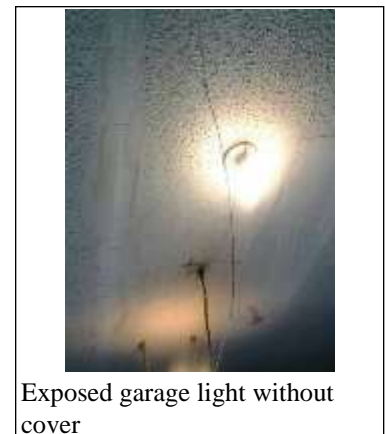
Exposed garage light without cover

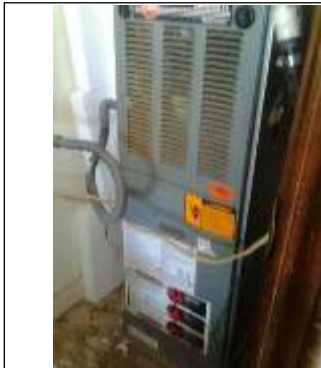
*Comments:* Ceiling area inside furnace cabinet is open to attic. Recommend that this should be enclosed and trimmed with flue pipe trim to add fire stop function.

Furnace cabinet gas line not bonded

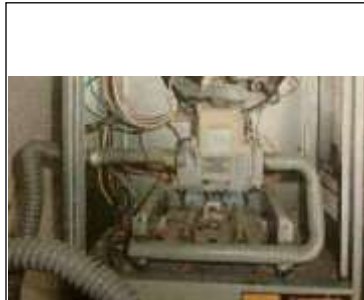
Gas flex line is feeding inside the furnace unit. It is recommended to add a vibration dampen/material by a qualified HVAC service tech.

Flexline coming into furnace

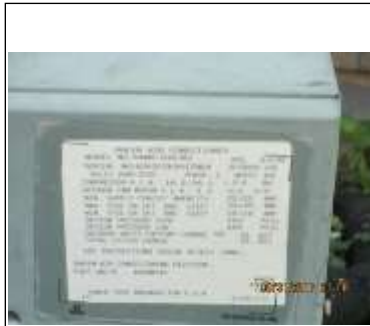
As is not uncommon for homes of this age and location, the air conditioning system is older. It may require a slightly higher level of maintenance, and may be more prone to major component breakdown. Predicting the frequency or time frame for repairs on any mechanical device is virtually impossible.

Outside AC unit mfg. July, 1999

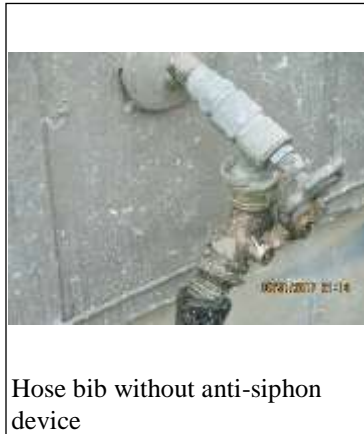
Hose bib without anti-siphon device

It is recommended that an anti-siphon device be added to the hose bib(s).

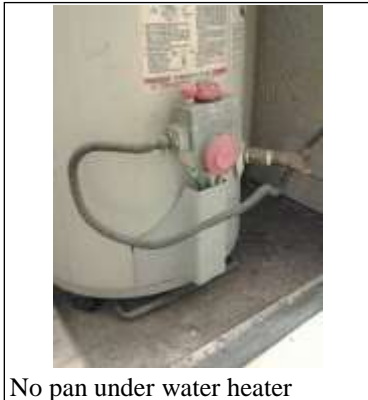
*Comments:* No sediment traps or drip legs at the gas lines at mechanical equipment. A drain pan is not present under the water heater. Because construction standards change over time, updating by a plumber will be required when appliances are replaced.

No pan under water heater

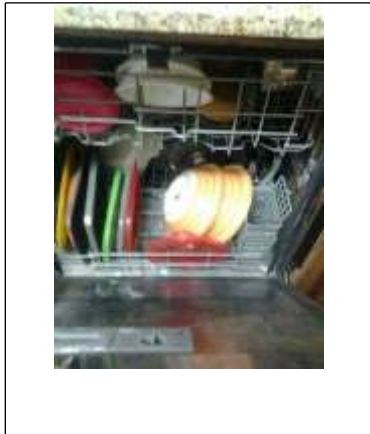
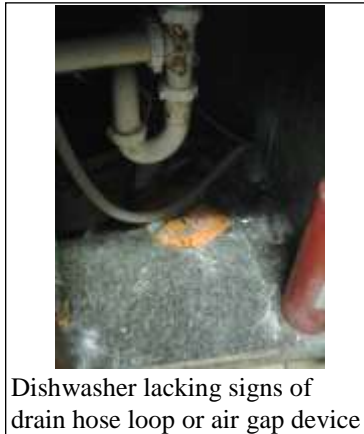
Dishwasher lacking signs of drain hose loop or air gap device

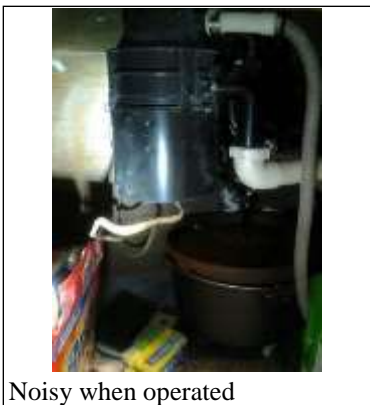
*Comments:* The food waste disposer is excessively noisy. Repairs or replacement may be necessary.

Noisy when operated

Have a plumber replace the waste disposal that is not operating.

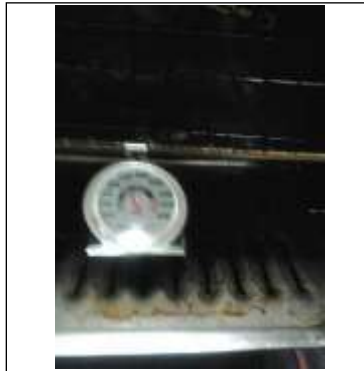
*Comments:* The oven was not securely fastened with anti-tipping device on free standing range. This condition should be repaired.  
Gas oven tested at 346 degrees when oven was set at 350 degrees. Well within the normal range of 25 degrees.

Blurred photo shows oven temp at 346 degrees,

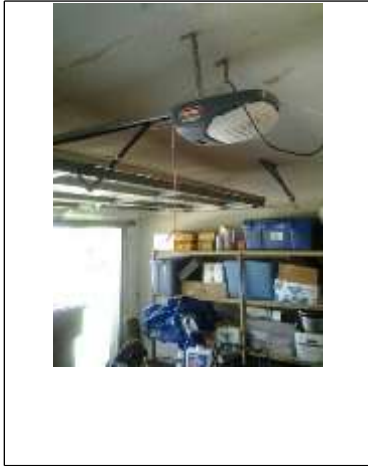
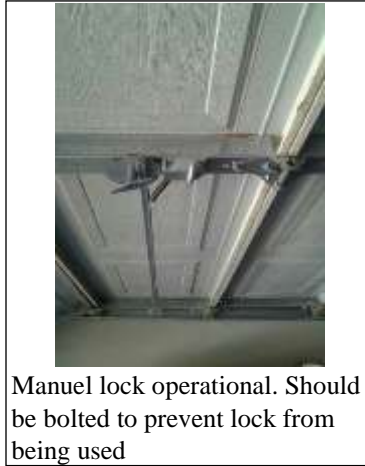
Comments: Garage door locking mechanism was still operational. With automatic garage door openers, it is recommended that the locking mechanism be locked out in open position.

Manuel lock operational. Should be bolted to prevent lock from being used

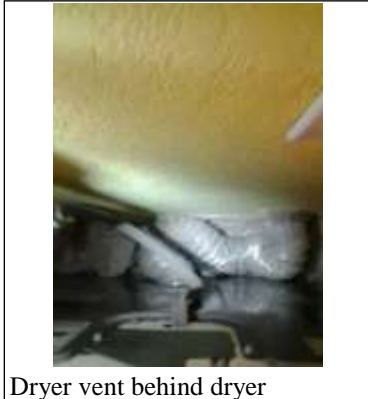
Dryer vent behind dryer

Comments: Recommend that the dryer exhaust vent be cleaned.
